MECHANIZED RIFLE TROOP (M113)

Monthly Test Report Number 6
1-31 July 1963

SUBJECT: Monthly Test Report Number 6 -- Mechanized Rifle Troop (M113) (1-31 July 1963) (U)

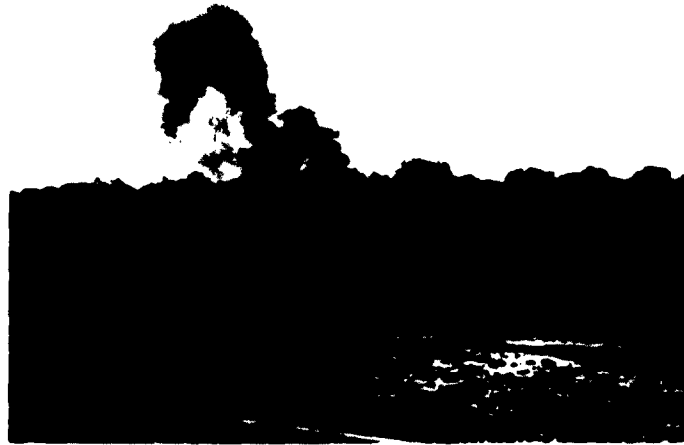
FIGURE 9

(U) M113-MOUNTED FLAMETHROWER IS USED ON THE ENEMY POSITION (VIEW FROM OPPOSITE SIDE OF POSITION)

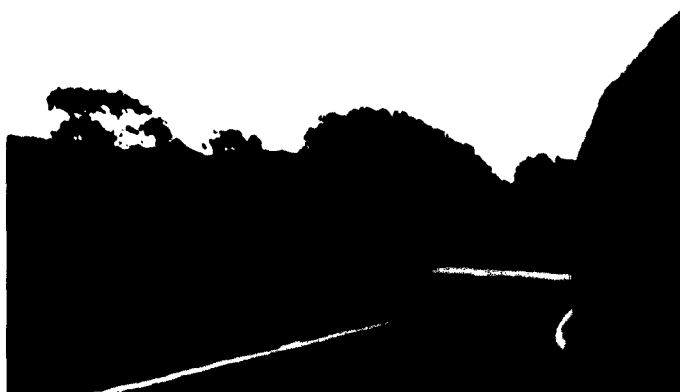
FIGURE 11
 (U) SECOND ASSAULT WITH CUPOLA-EQUIPPED M113S. THE TWO CUPOLA-EQUIPPED M113S AND THE M113 SEEN IN THE FOREGROUND ADVANCED 150 METERS INTO THIS WOOD LINE BEFORE BEING ORDERED OUT.

Four enclosed caliber .30 machine gun cupolas have been mounted on the M113 for test in the ARVN. This cupola will afford added protection for the gunner. Two cupolas are mounted on 1st Armored Cavalry Squadron vehicles assigned to III Corps and are located at GO VAP. They have not been employed sufficiently to develop any preliminary information. The remaining two cupolas are mounted on 2nd Armored Cavalry Squadron vehicles and are located at MY THO. They have been employed in two operations to date. Preliminary information from these two operations indicates the following:
